RE: Masonry Restoration and Related Work, Phase 2
Canal Place Condominium
Lowell, Massachusetts

FIELD REPORT

Project: Masonry Restoration & Related Work
Canal Place Condominium
Lowell, Massachusetts

Date: 4/29/15
Project: #13294
Report: #1B

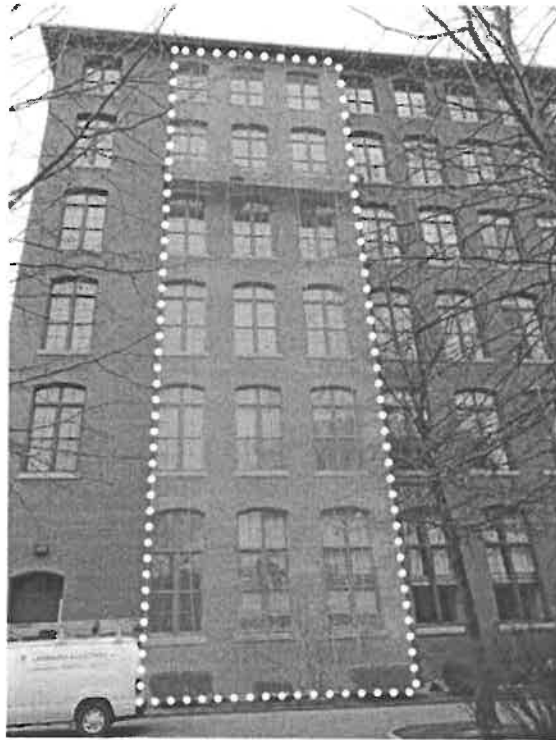
- 1) Swing staging has been erected on the 1st staging drop on the east end of the north building elevation (Photograph 1). Cutting of the masonry mortar joints on this drop is complete and new mortar placement will be completed by the end of the week (Photograph 2). A workman is also moving across the wall at ground level cutting and pointing joints (Photograph 3). The staging will be moved to the second drop early next week.

Photograph 1 – The masonry in the 1st staging drop is located within the dotted rectangle.

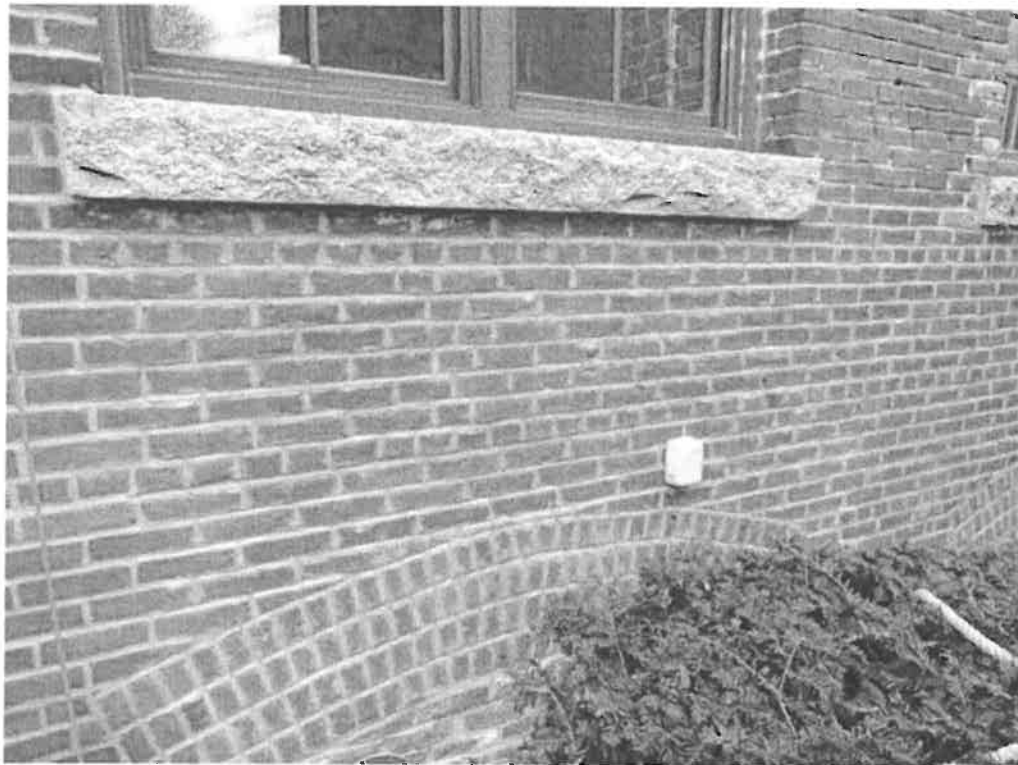
Photograph 2 – Newly pointed mortar joints at the base of the 1st staging drop.

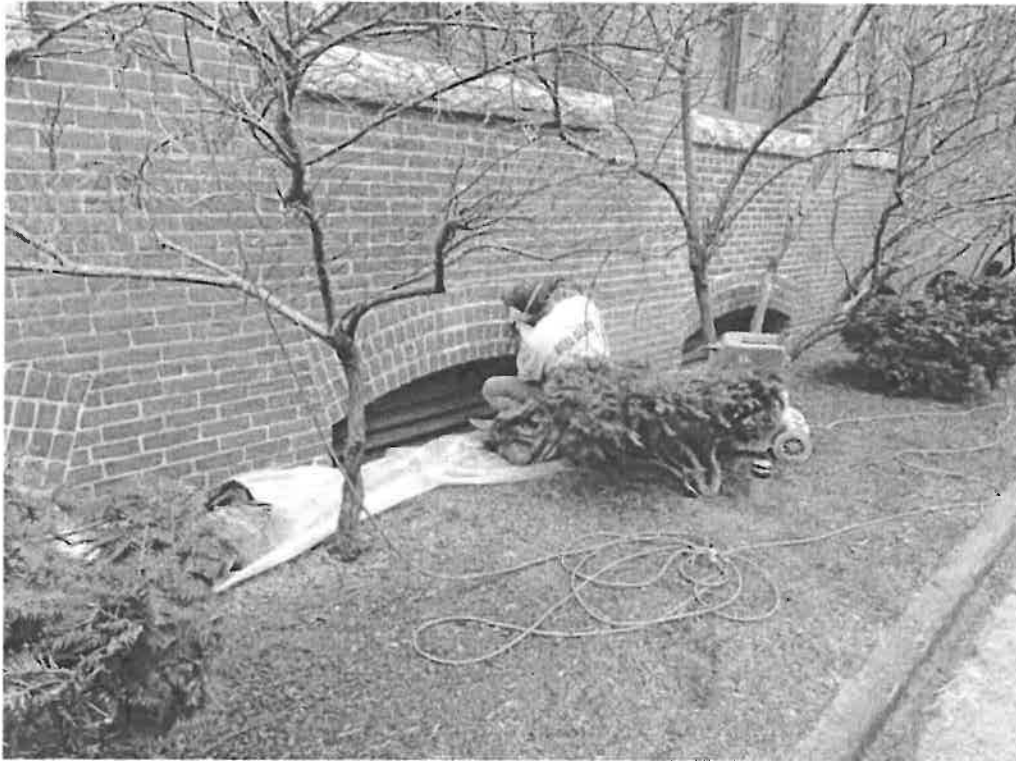
Photograph 3 – Workman cutting mortar joints in ground level masonry.
